**TRANSPORTATION SAFETY  
BUREAU**

**ANNUAL REPORT 2014**  
**Transportation Safety Bureau**  
**Hungary**

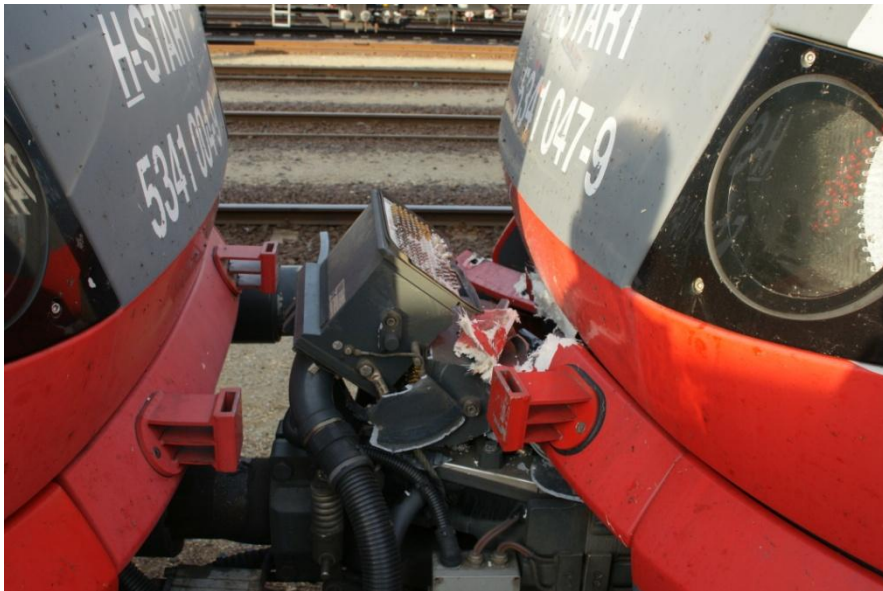
## **2012-240-5**

The train No. 34429 approaching Tatabánya Station through the occupied track 6 bumped into the train set of the still train No. 4859 at low speed. Two persons travelling on the train has slight injuries, and the central switching systems of both trains were damaged. The IC attributes the occurrence to human factors on the part of the engine driver of the train No. 34429.

The engine driver of the train No. 34429 fell asleep while the train was approaching the station, so he failed to stop his train in front of another train staying ahead of it.

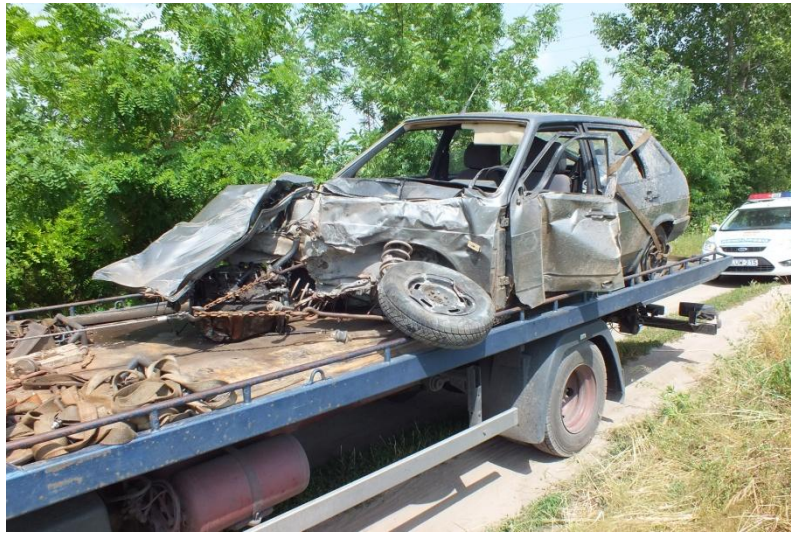
**2012-402-5**

The railcar No. 6341-002 of the train No. a 7807 collided with an automobile at the unprotected level crossing in Section 732 between Baja and Mátéházapuszta Stations. The driver of the automobile died on the spot as a consequence of the crash, and his passenger had severe injuries. The IC attributed the occurrence to human factors on the part of the driver of the automobile. During the technical investigation of the occurrence, the IC found the sight at the level crossing noncompliant, and thus, the TSB issued a safety recommendation to the Bács-Kiskun County Government Office. The Government Office obligated MÁV Zrt. and the adjacent lands in a Ruling to provide the required sight, which the affected parties performed by 4 October 2012.

The required reduced sight triangle was not clear from the direction of arrival of the automobile, it was covered with vegetation.

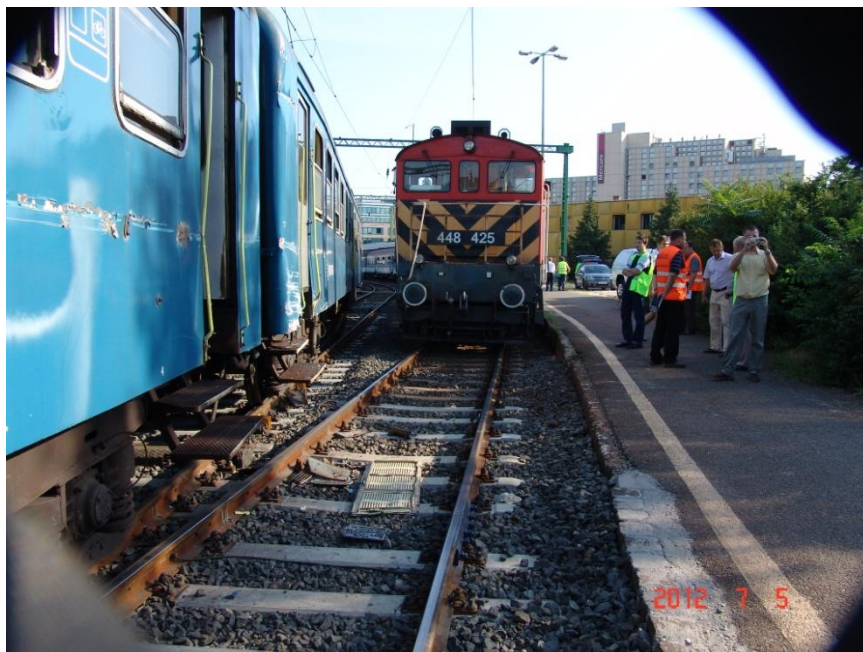
The IC concluded that visibility along the track section involved in the occurrence is difficult due to the significant interference by the built environment.

The IC concluded during the technical investigation that the occurrence is primarily attributable to human factors.

For the sake of preventing similar cases and minimising the time needed to check the track visually, the IC recommended the National Transport Authority to review the rules relevant to the traffic managers' obligation to view the tracks as defined in the Station Instructions for Budapest Déli Station, and thus ensure (by some technical development or work organisation measure) continuous visibility of the switching zone around the tracks Cs1 to Cs3 for the station crew that manage train traffic.

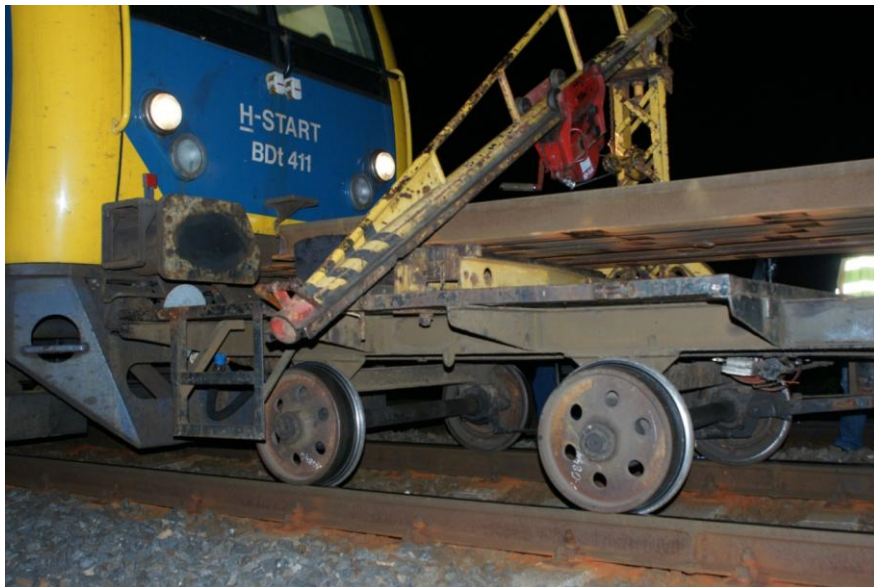
According to conclusions of the IC, the cause of the occurrence was that the track motor car and its trailers had been connected otherwise than specified by the requirements (the pin which fastens the connection was not secured against falling out) at the departure station of the train No. 23399 (Újszász Station). A contributing factor to the occurrence was that the main line hose connection between the track motor car and its front trailer was not connected, which excluded automatic braking in the case of possible accidental disconnection. Another contributing factor was that the brake systems of the (3) trailers were disabled, and thus, the braking of the disconnected train section was impossible.

The occurrence may be attributed to technical and human factors.

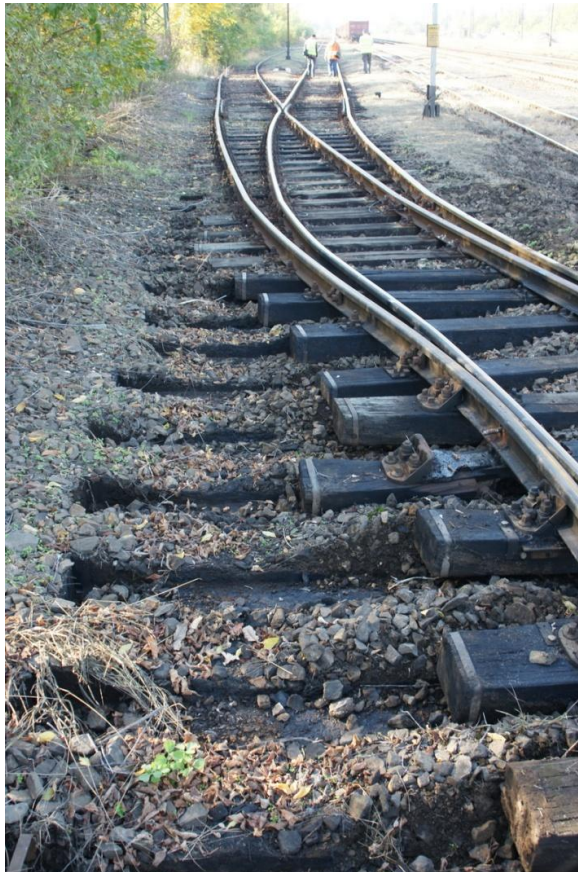
An investigation of the system of track maintenance showed that the worn-out state of the sleepers (which led to the accident) in the actual turnout were not explored, and the resources and materials necessary for adequate track maintenance are not provided; the performance of maintenance tasks is complicated by complex and slow decision-making processes.

There was an increase in the track gauge at the spot of the derailment, and the structure of the track could not resist the impact of the forces which caused further, flexible increase to the track gauge.

The TSB issues a safety recommendation relevant to making the dimension specifications of the turnouts more precise.

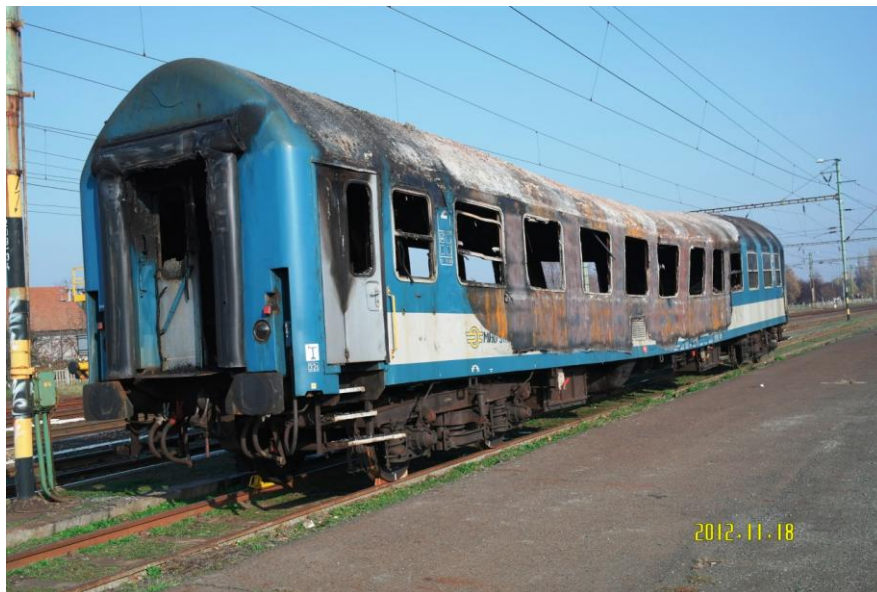
due to structural layout of the safety thermal cut-out integrated into the heating system of the passenger wagon, it could be mounted in its fixed, disabled (i.e. inoperable) state as well, which prevented its normal operation;

the procedures (specified in instructions) to be followed after detecting malfunction of the heating system were not followed, and thus, no action was taken to repair the defective rolling stock at the reversing station of the train.

The IC attributes the occurrence to a combined effect of several factors:

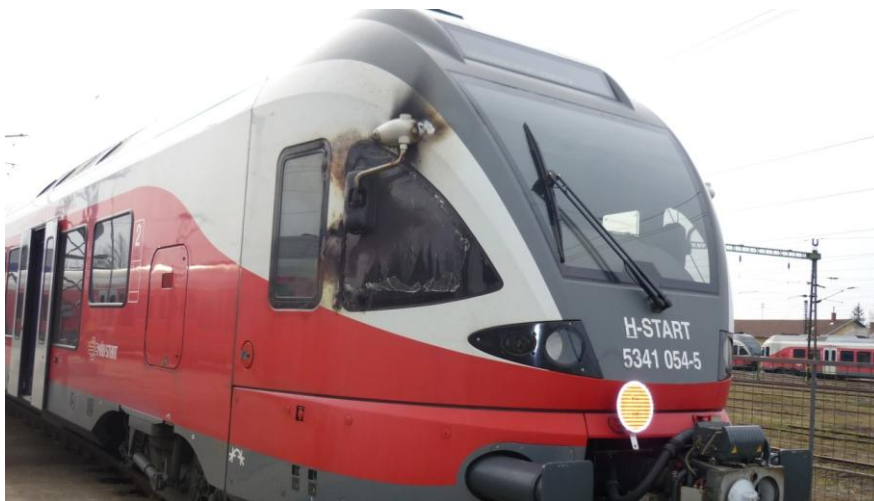
The IC concluded that the train No. 4829 was allowed to access the station without localising exactly the permanent short circuit in the overhead contact wire network of the station, and without making sure that the structure clearance was maintained.

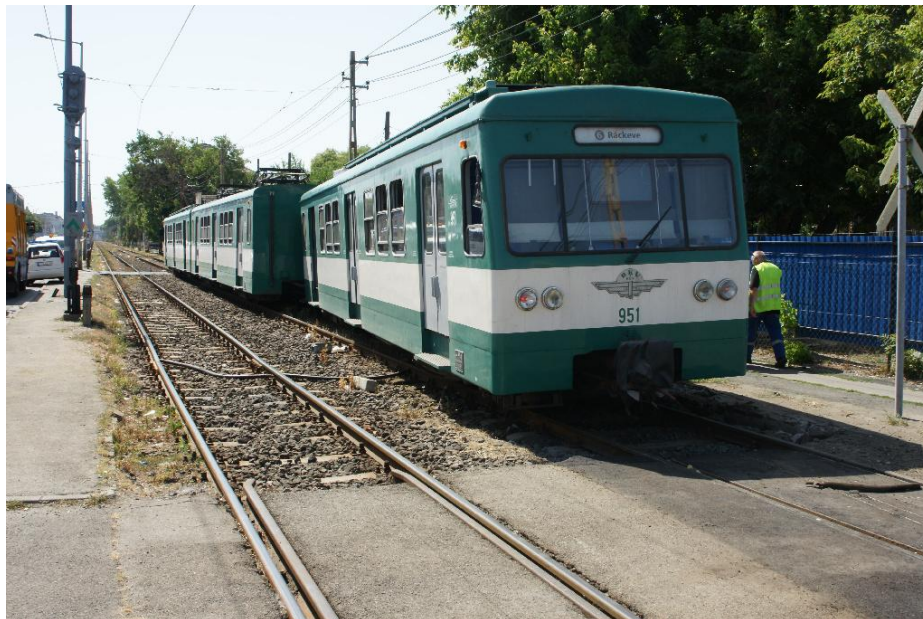
The IC concluded that the derailment was caused by a broken spring cover the fastening bolts (probably the same age as the vehicle) of which had broken due to fatigue of the material. The inspection technology used during the periodical maintenance of the vehicle is not able to reveal such defects.

A fastening bolt of the cover of a spring bearing the wheel load of the vehicle sustained fatigue breakage which had not been detected before the accident; breakage of the second bolt was not detected either.

The operating undertaking modified the technology of inspection of the vehicles during the technical investigation, and they also took action to replace the bolts with similar function in all vehicles.

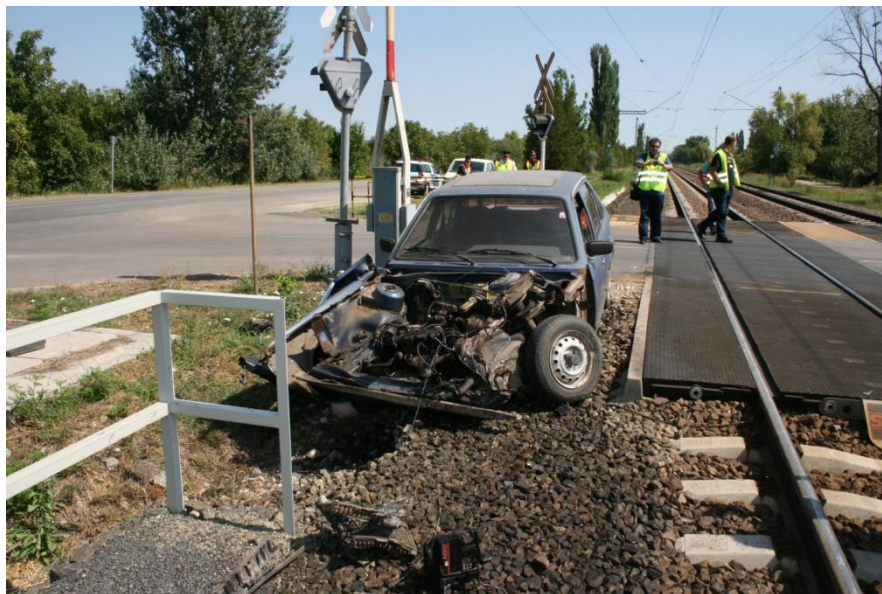
The warning lights and the half-barrier were in failure state, i.e. unfit for their function. The operation of the protection system had been uncertain during the month preceding the accident as well, the cause of which was not revealed during that period. The driver of the automobile drove his car as a routine, checking the vertical state of the half-barrier bars only, but neglecting the warning lights.

As the railway infrastructure operator repaired the installation after the accident, and the errors have not recurred, thus it is not necessary to issue a safety recommendation.

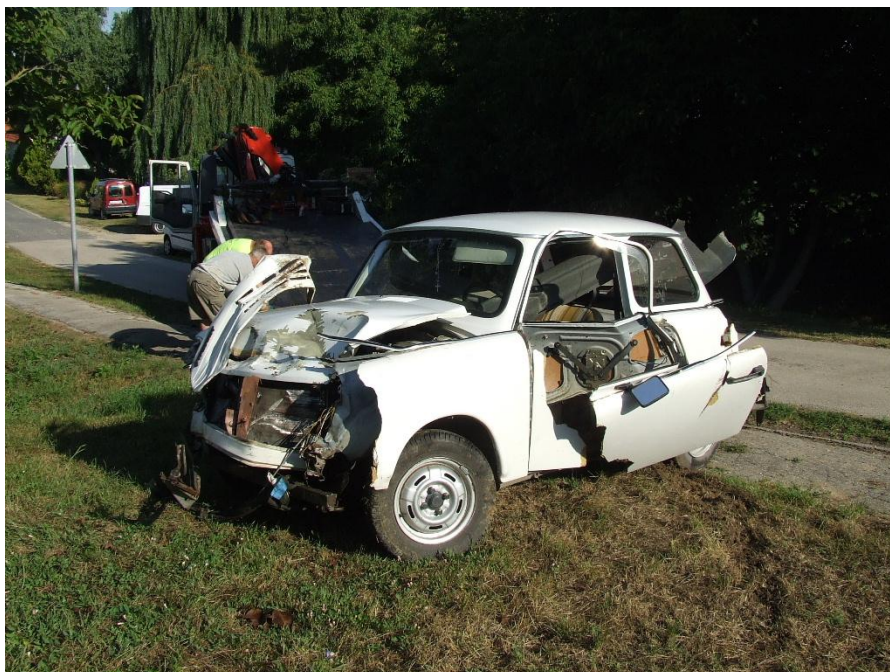
The IC attributes the accident to human factors on the part of the driver of the automobile.

The TSB issued a safety recommendation, on the basis of which the competent government office organised a tour of inspection in order to review the safety of the level crossing. Relying on the minutes of the tour of inspection, the government office will obligate the railway infrastructure operator to introduce a speed limit corresponding to the actual sight triangle.

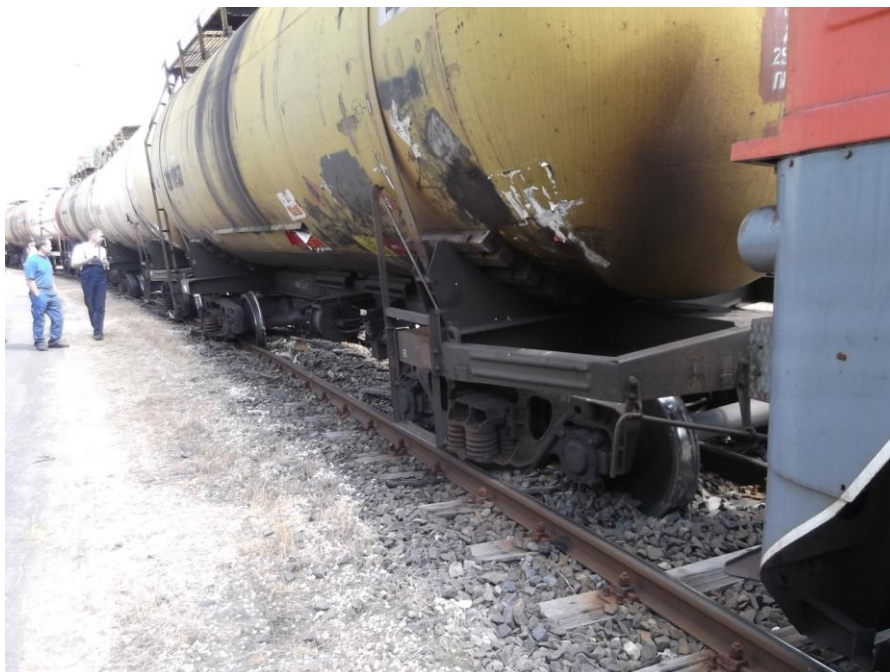
Doubts emerged in connection with the validity of the documents of the pre-installation qualification of the wooden sleepers; the quality inspection (if there was any) did not indicate adequate saturation.

The direct cause of derailment was the inadequate stability of the wooden sleepers which did not provide a constant track gauge, i.e. was not able to maintain the framework strength.

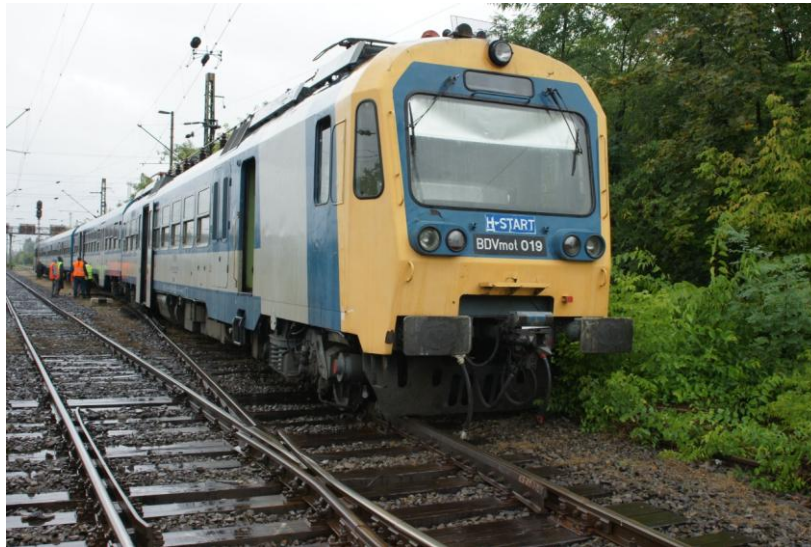
**2013-764-5**

The train No. 20216, providing service on the line between the Stations Budapest-Nyugati – Rákosrendező – Istvántelek, derailed with 4 axles on the set of points No. 507 (turnout direction) of Rákosrendező, running opposite the switch tongue. No one was injured, but the railcar of the train set sustained minor damage. The IC attributed the occurrence to breakage of the point wire of the points No. 507, but stated at the same time that the layout of the points and the safety installation do not comply with the requirements specified in the relevant standard. Accordingly, the IC proposes that a safety recommendation be issued in which the construction of an end position control and reconstruction of the technology of the railway station would be recommended.

During the operation of the points No. 507 the point wire broke, and thus the points did not reach the end position. However, the switch positioning lever clicked to place, so the safety installation allowed the operation of the exit signal. The train rolled onto the “open” points, and derailed.

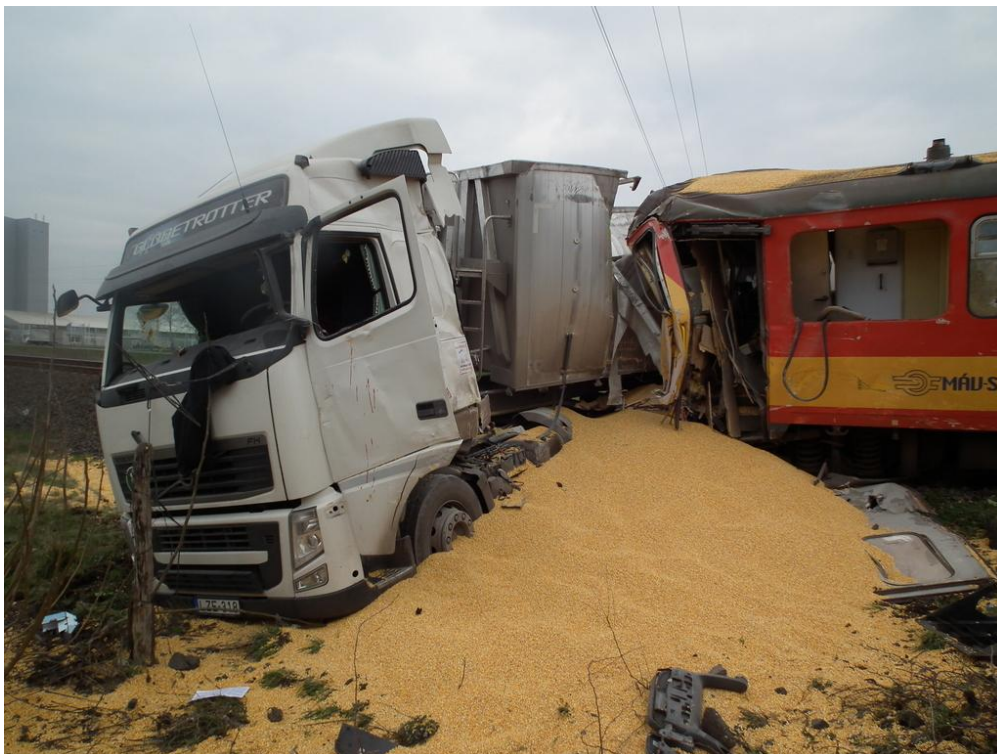
The layout of the road relevant to elevation allows a low structural element of a road vehicle to get caught on it.

During the technical investigation, the TSB issued a safety recommendation to the Inspectorate of Transport of Csongrád County Government Office. The Inspectorate had taken action to have the level crossing repaired and provide the sight triangle independent of this. The Government Office ordered the affected parties to perform the aforesaid measures.
